Soluble Salts in Porous Materials:
Evaluating Effectiveness of their Removal

A THESIS

Historic Preservation

1999

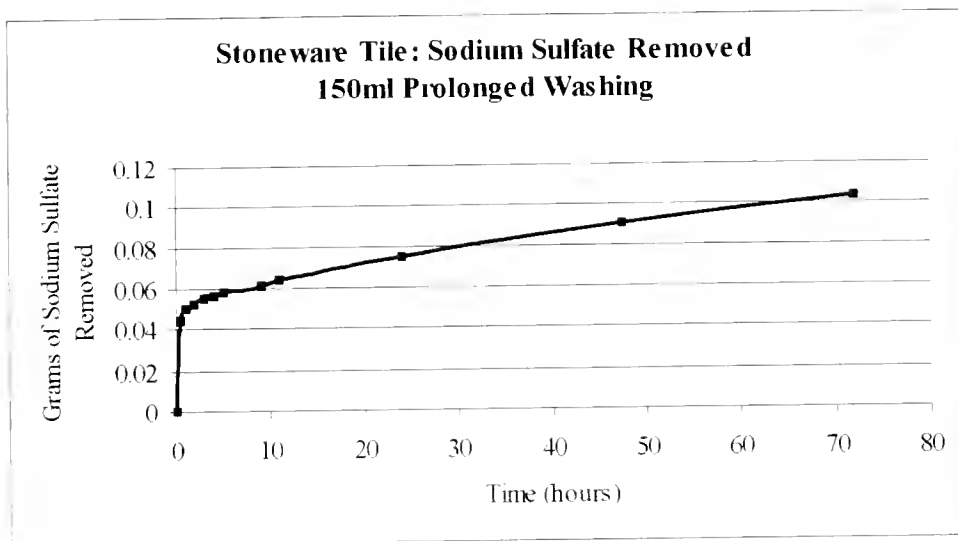
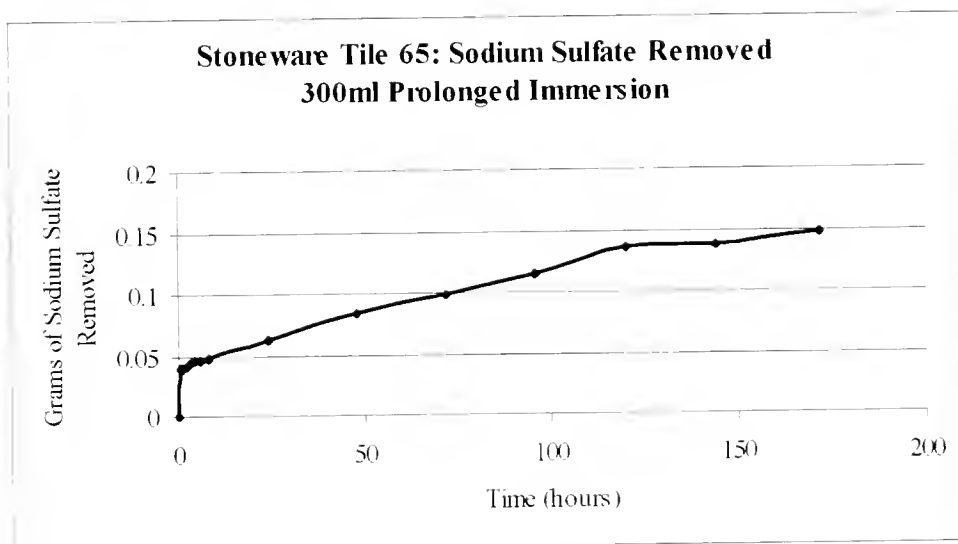
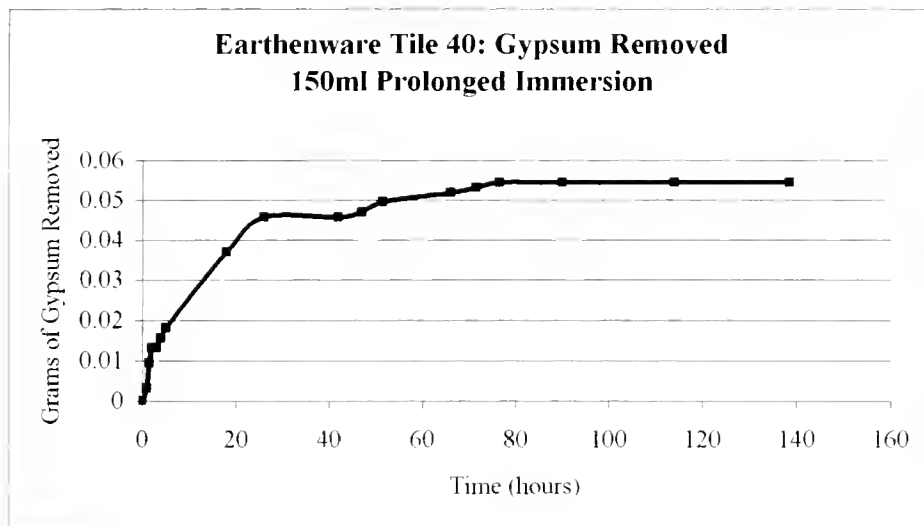
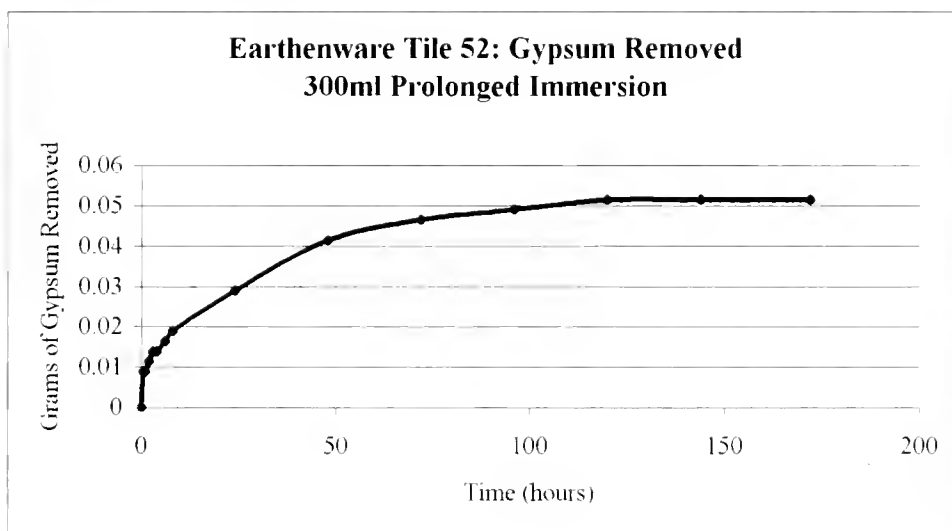
Graph D7: Grams of Sodium Sulfate Removed During 150ml Prolonged Immersion of Stoneware Tile

Graph D8: Grams of Sodium Sulfate Removed During 300ml Prolonged Immersion of Stoneware Tile

Graph D9: Grams of Gypsum Removed During 150ml Prolonged Immersion of Earthenware Tile

Graph D10: Grams of Gypsum Removed During 300ml Prolonged Immersion of Earthenware Tile
